**Ho Sin Hang Campus – Repair Works to External Wall of Corridor from
Levels 6 to 12 of Oen Hall Building**

善衡校園 – 溫仁才大樓六至十二樓走廊外牆維修工程

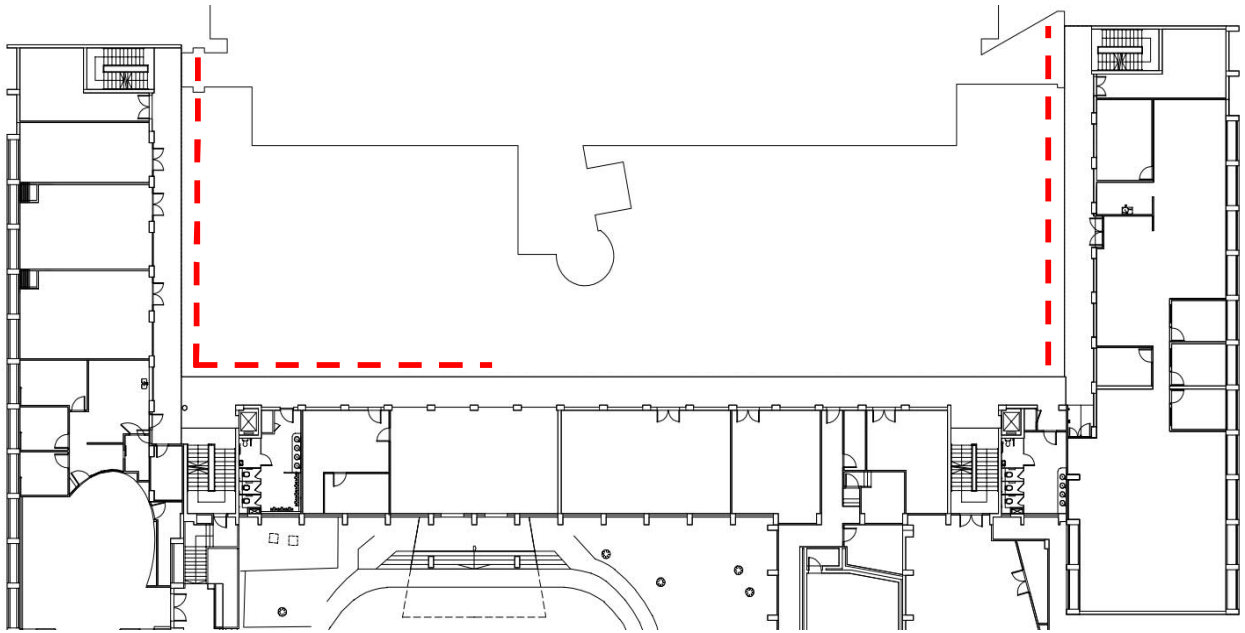
--- Scaffolding area 6/F – 12/F
